## Grounding and subsequent loss of the dive support vessel *Jean Elaine* in Saint Peter’s Pool, Orkney Islands, Scotland on 22 July 2024

### SUMMARY

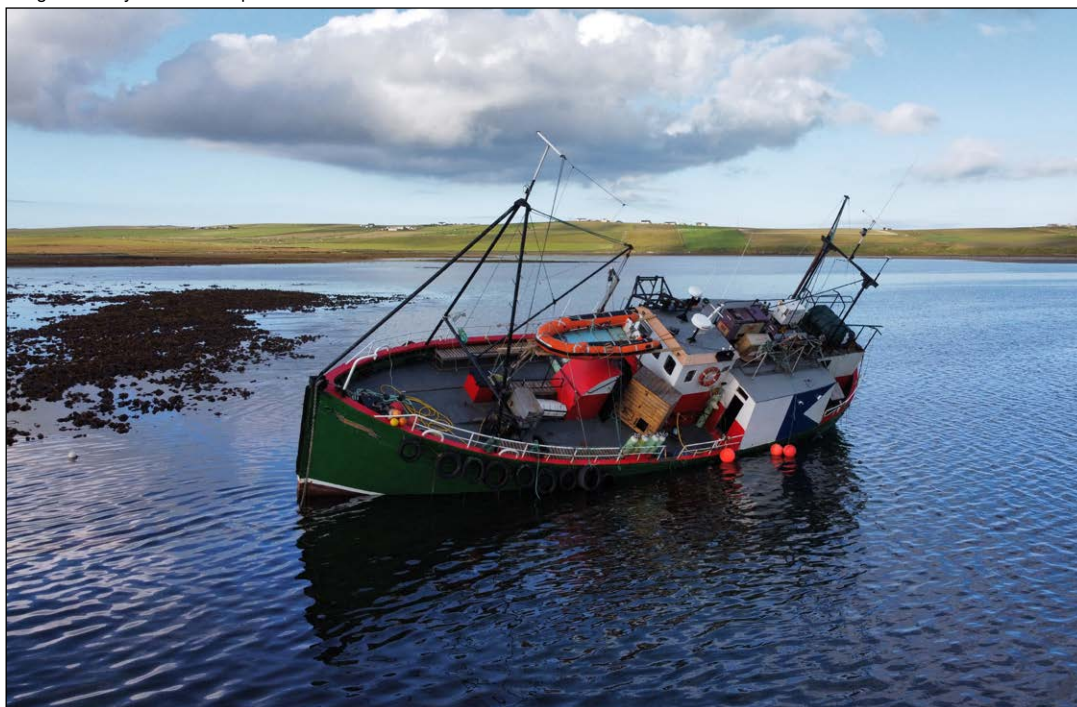
**Figure 1:** *Jean Elaine* grounded in Saint Peter’s Pool

The skipper attempted to manoeuvre the vessel free but, after trying for approximately 20 minutes, decided to wait, expecting the vessel to refloat on the high tide. *Jean Elaine* adopted a list to port as the tide receded.

As the tide continued to fall, *Jean Elaine's* list worsened (see **Figure 1**). The skipper shifted four large air bottles from the port side of the wheelhouse to the starboard gunwale to try to counter the list, but this had no effect.

As the list increased further, the crew noted water had entered the engine room and the bilge alarm for the aft cabin sounded. *Jean Elaine* lost power, rendering the on board electric pumps inoperable. A fault caused the emergency generator to trip and the skipper decided to switch it off.

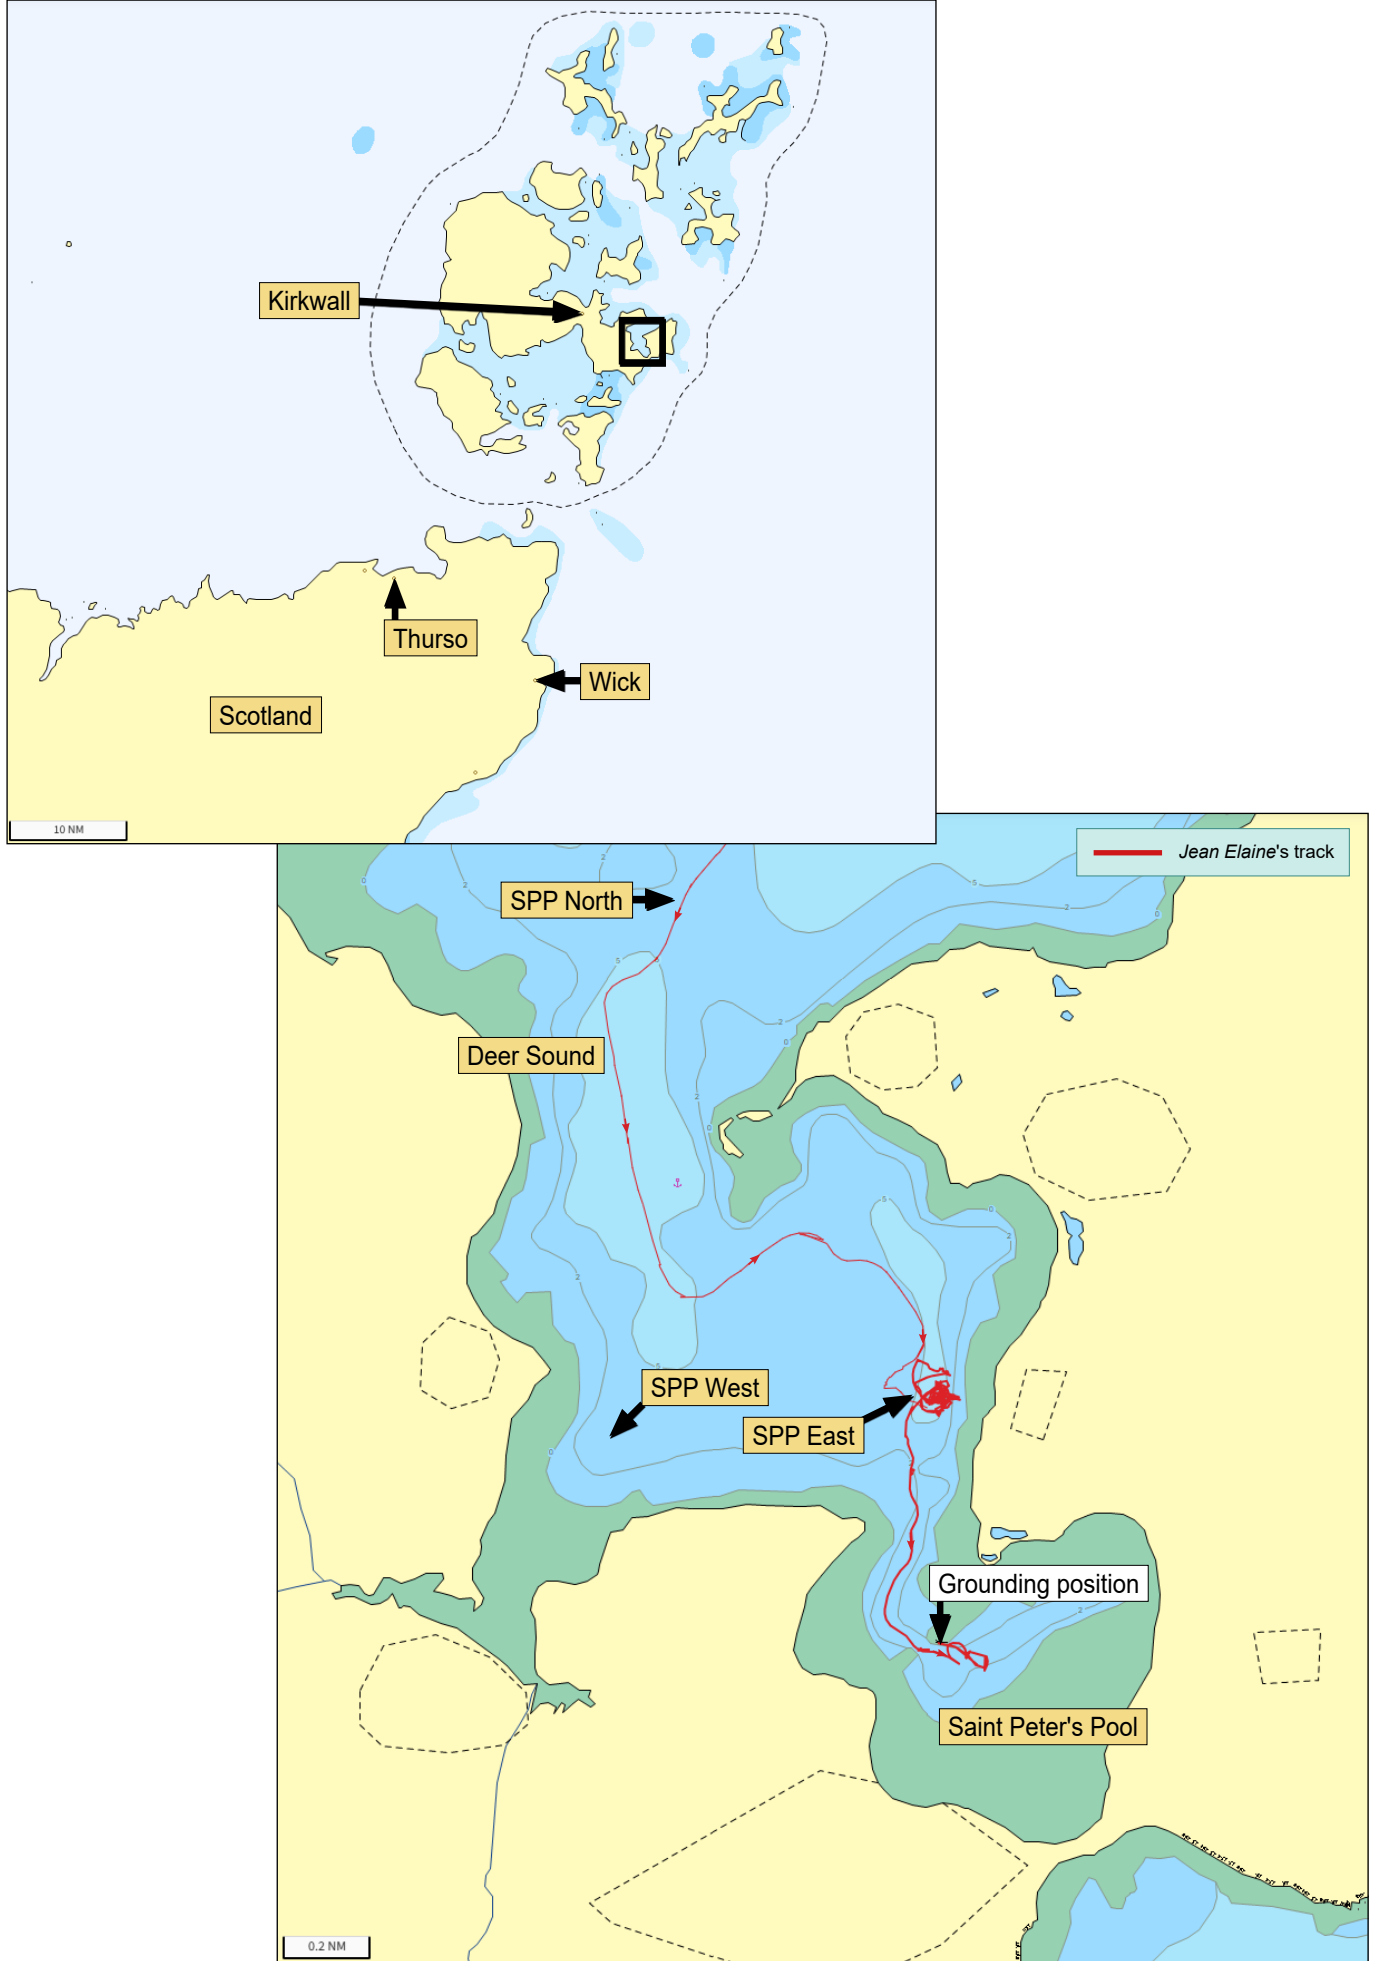
**Figure 2:** Jean Elaine's track, grounding position and the three pre-identified dive sites in the (inset) Orkney Islands

Once the mate and Project Seagrass diver were back on board, the skipper turned *Jean Elaine* to exit Saint Peter's Pool. At 1500, during this manoeuvre, *Jean Elaine* grounded (**Figure 2**).

Deer Sound is an inlet on the east coast of Mainland, Orkney Islands. The inlet opens to the north-east between Rerwick Head and Mull Head and contains several smaller inlets (**Figure 2**), of which Saint Peter's Pool is one.

The project plan identified three survey locations within Deer Sound, labelled SPP North, SPP East and SPP West (see **Figure 2**). Though the project plan named Saint Peter's Pool within it, none of the survey locations were within the pool and the plan did not contain any contingency to expand the scope of survey should the nominated sites prove unsuitable.

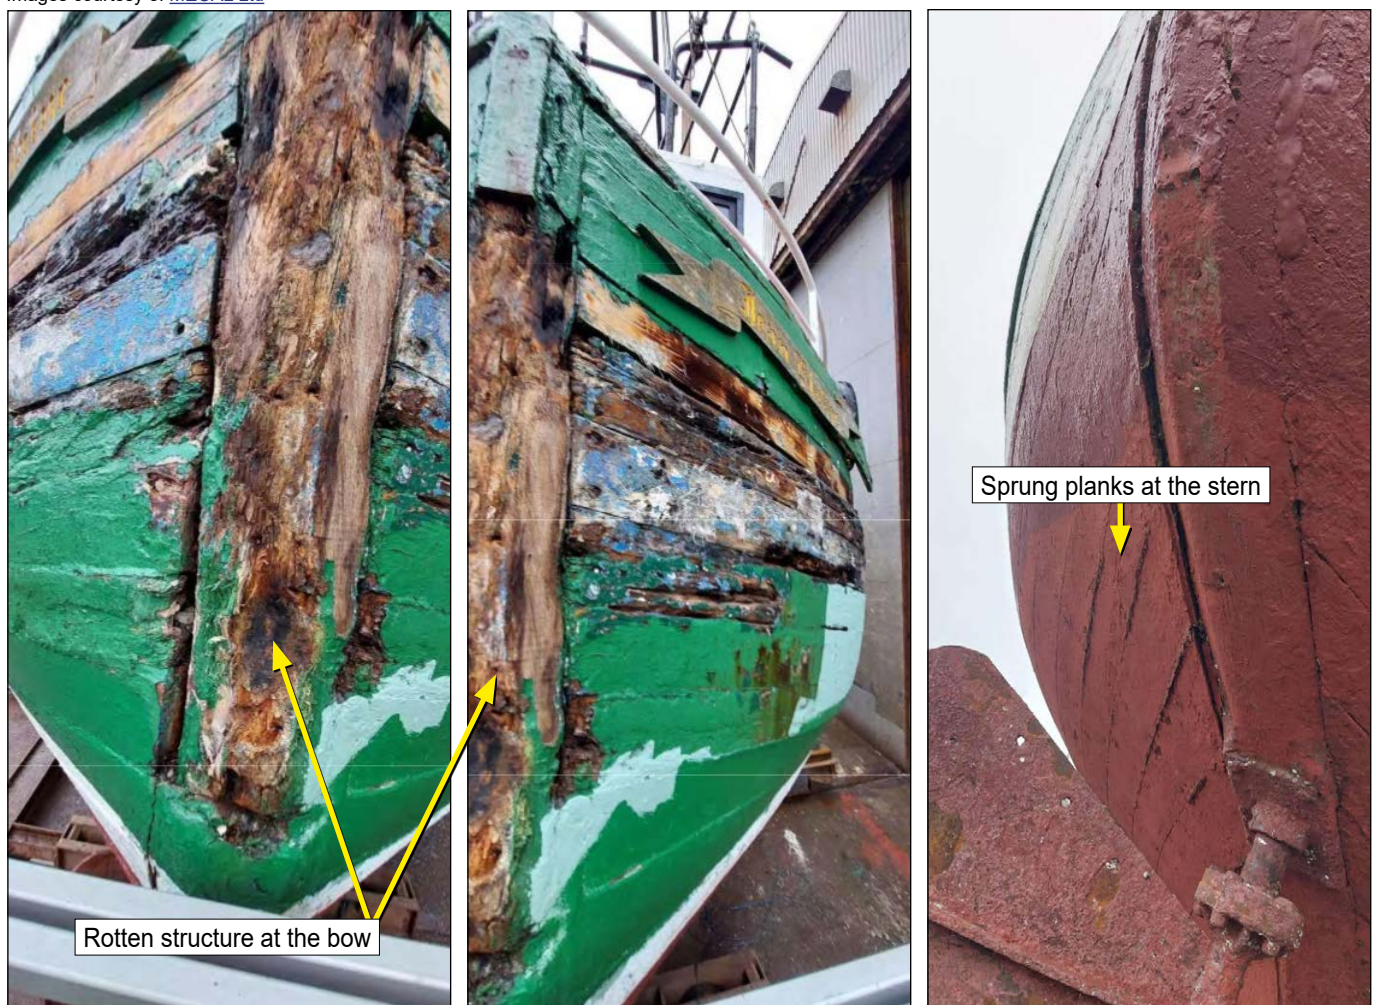
On 29 April 2024, *Jean Elaine* was examined out of the water for the renewal of its certificate. The examination was carried out by MECAL Ltd, a certifying authority authorised by the MCA to survey and certify vessels under MGN 280 (M). The survey identified sprung and rotten hull planking (**Figure 3**) and the certificate held by *Jean Elaine* was not renewed. The suspension of certificate notice issued by MECAL Ltd to the skipper of *Jean Elaine* stated that, *While this suspension notice is in force, the vessel must not operate commercially*.

**Figure 3:** *Jean Elaine*'s hull defects in April 2024

*Jean Elaine* was not certified for commercial operation at the time of the accident as the vessel's certification had not been renewed following the survey in April 2024, which identified significant structural issues with the hull. Its insurance was invalid due to the lack of certification. The poor condition of the hull planking likely reduced its ability to resist the localised loading it experienced as *Jean Elaine* listed onto the seabed as the tide fell. Additionally, the skipper had not revalidated their certificate of competence. Given the requirements for revalidation of the skipper's Yachtmaster Offshore qualification, it was unlikely that this omission contributed to the accident.
